ARCHITECTURAL CONSERVATION: A CASE STUDY OF MULTAN JAIN SWAMBER TEMPLE

METHOD

RESULT AND DISCUSSION

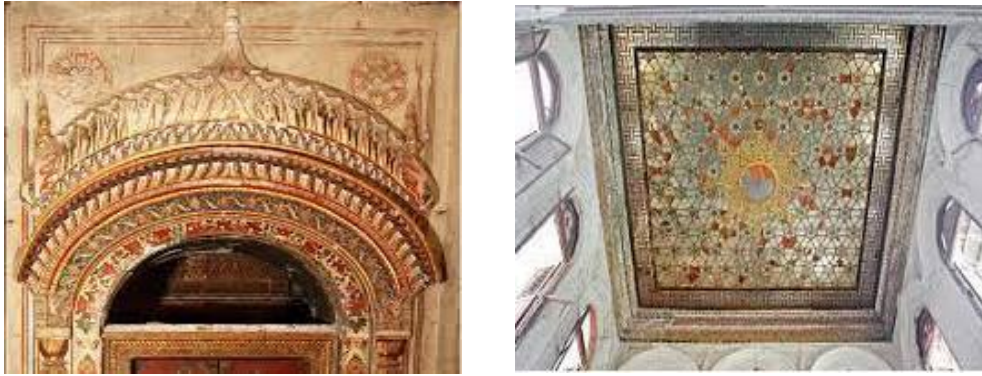
If no quick action is taken, the building may collapse at any time, causing significant damage to life and property. The inside floor appears to be original, and it is laid in white and black marble. However, it is in terrible condition. The columns are octagonal, with a lousy plaster finish. Similarly, the plaster on the roof ceiling is in disrepair. Taksim Bandi is used on the roofs, while Hindu patterns are used on the walls and niches.

Figure 2. Interior carving of Temple

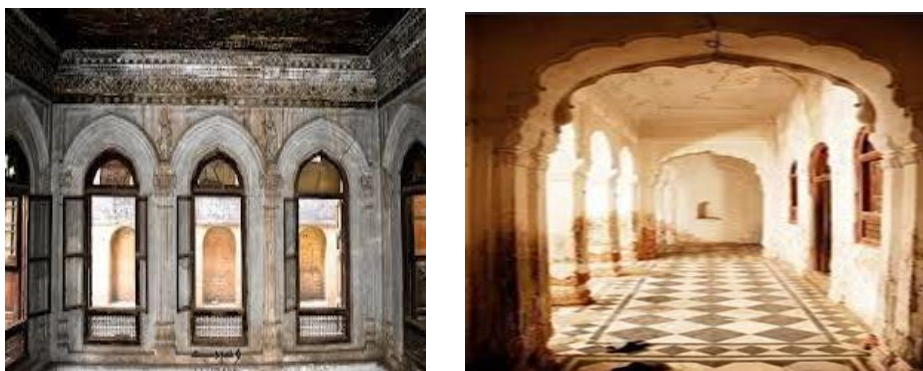
A typical temple Jain sakhara with melon-shaped capping (dome) and a pinnacle or kalas is located above the main hall. The door frames are beautifully carved and, in some instances, are adorned with magnificent jallis. The wood carving on the main entry door reads "ShiriVishwanath Jain Shwetambar Mandir," the temple's original name. A big wall painting on a massive marble slab depicts what looks to be a road plan giving entrance to some religious site in one location. This temple somehow resembles with Jaina Temple (Bhabra Mandar) in Gujranwala which is presently on exhibit in the Lahore Museum. The walls of temple are partially carved and partially painted map on two marble slabs. On the two extreme wings, there are two staircases leading to a basement/lower ground level. A chamber on the first level looks down over the main hall in the center.

Figure 3. Door and windows designs of Temple

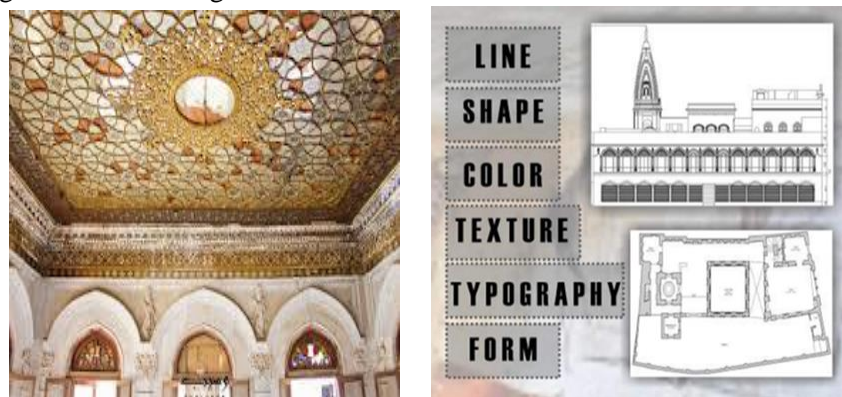
The floors and windows of the temple are beautifully designed, keeping in view the all characteristics of design and its elements. Most of the courtyard and verandah are marble tiled, while some of the terrace floors are made of PCC concrete. Vandalism has resulted from the attachment of a nearby building's air conditioning unit to the fabric of the Mandar.

Figure 5. Surface design and pavement of Temple

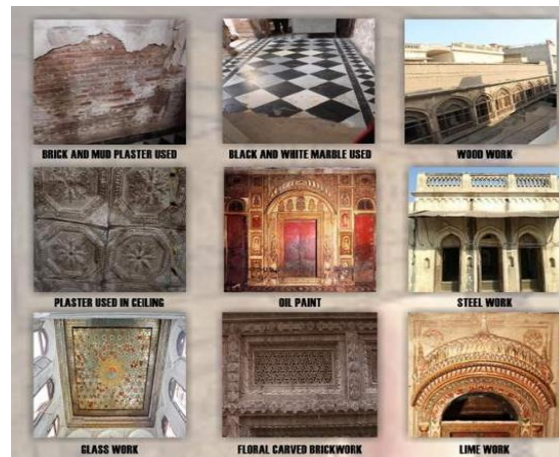
The central area of the temple is supported by pillars made of bricks whose bases have been eroded by humidity. Walking on the leading site of the first floor creates vibrations due to deflection. Severe separation fractures may be seen in the walls of the side chambers, as well as multiple cracks were observed on the openings of all rooms and in the recessed arches and walls. Dampness is rising in the walls, which is exacerbated by an ablution area. Most of the walls and the ceiling vaults are infested with dangerous and severe cracks in the roof, destroying its minor components. Above all entrances, the external walls contain fractures. Overall, the situation is dire, with a high risk of collapse.

Figure 6. Material used in Temple

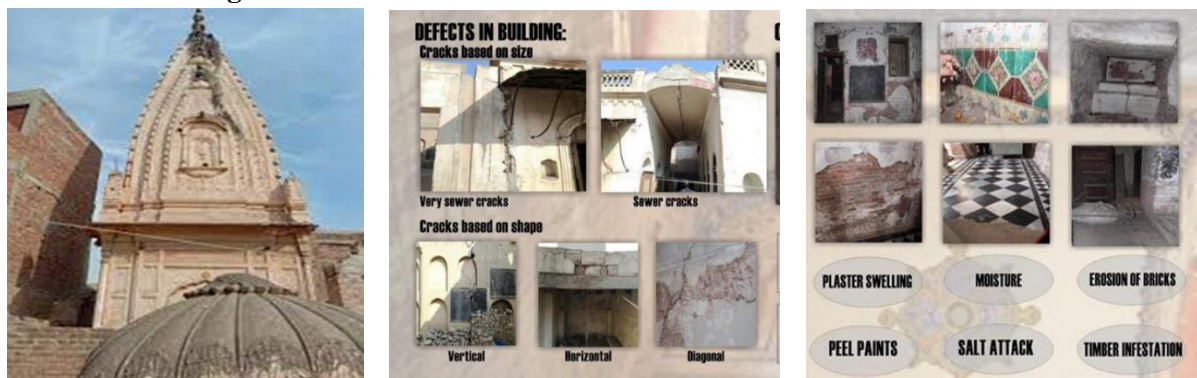
Figure 7. Existing defects in Temple building

Even though a madrasa operates within the premises, the Jain Swamber temple is in reasonable original condition, with a significant number of original decorative features retained. Structural flaws result from poor care, and the structure needs rapid stabilization. Since its construction, no significant changes appear to have been made to this structure. Construction of a partition wall, a blackboard

supporting wall, or a tiny water tank is only a few of the interventions that have been found so far. The structure is being harmed by leaks from the water taps and sewage lines, presumably constructed recently by the Madrassa regime (Mahajan, 2007).
